Aquatic Biodiversity Compliance Statement – Carolus Solar Photo- Voltaic (PV) Solar Energy Facility and associated Grid Connection Infrastructure

**Pixley ka Seme District Municipality,
Northern Cape Province**

Report Date: September 2022

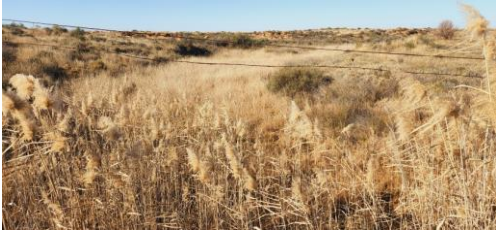
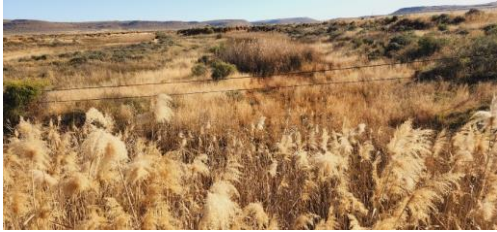
Comments	Upstream Brak River site, upstream and east of proposed infrastructure. The watercourse presented wetland habitat and was dry.	
GPS-coordinates	30°40'42.52"S 24°10'45.43"E	
Brak Down

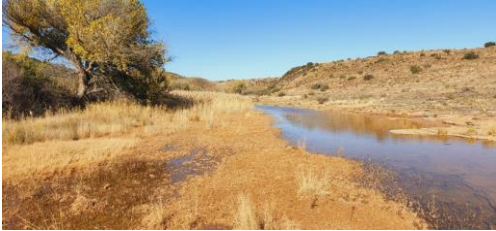
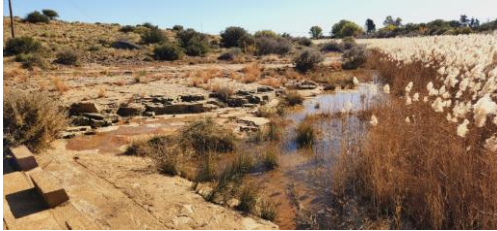
Comments	Downstream Brak River site, downstream of proposed infrastructure and downstream of Brak Mid. The site presented wetland habitat. The site was deemed too shallow and unsuitable for standard aquatic sampling methods and was limited to <i>in situ</i> water quality analysis only.	
GPS-coordinates	30°38'18.43"S 24° 8'12.64"E	
Brak River tributaries		
East Trib Dam

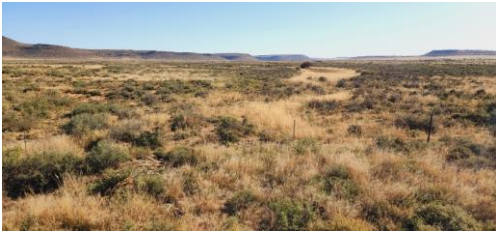
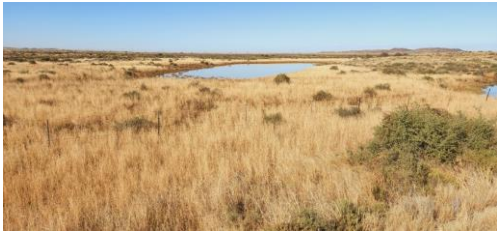
Comments	Located at a Dam on a Brak River tributary to the east of the project area (Eastern tributary). The site is downstream of the Carolus Solar PV1 Footprint and would drain into the Brak River upstream of Brak Mid. The dam had surface water and water quality analysis was conducted at this site.

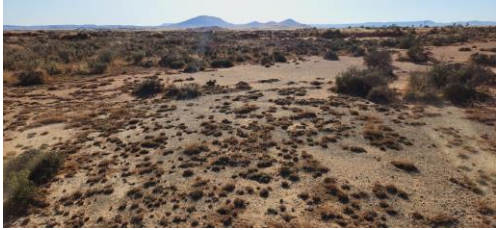
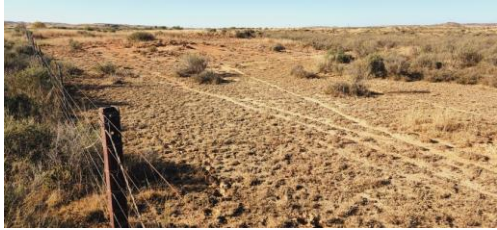
Site	Upstream	Downstream
Comments	Located on the major Brak River tributary within the western portion of the project area. The site assessed the upper portion of this tributary (Western Tributary) that will be traversed by the proposed linear infrastructure (powerlines and roads). This site was presented by a wide drainage area (alluvial floodplain) with an inconspicuous channel, which was dry at the time of the survey.	
GPS-coordinates	30°42'39.68"S 24° 6'36.75"E	
West Trib 3

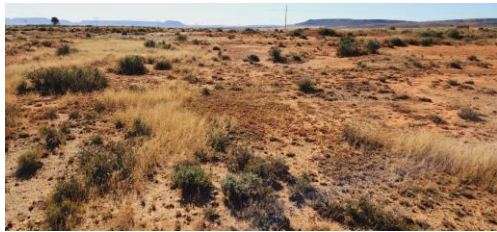
Comments	Located on the Western Tributary in the lower portion of this tributary that will be traversed by the proposed linear infrastructure (powerlines and roads). This site was presented by a wide drainage area (alluvial floodplain) with an inconspicuous channel, which was dry at the time of the survey.	
GPS-coordinates	30°38'50.53"S 24° 6'0.03"E	
Artificial Dam

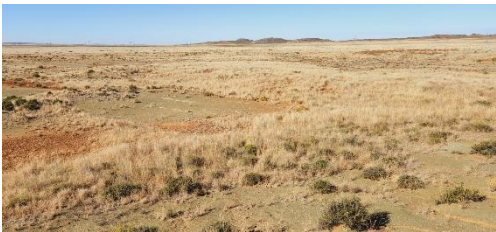
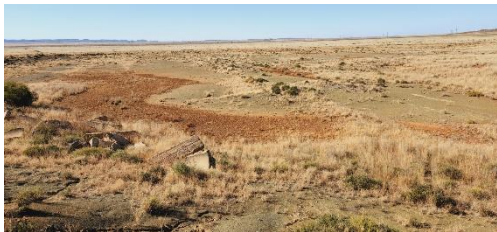
Comments	A dam located along a public road with no clear drainage lines. The dam is located adjacent to the BESS area of the PV area. The dam is considered artificial and a result of the presence of the road. The site was dry and considered to have low aquatic ecology importance or sensitivity due to its artificial nature.

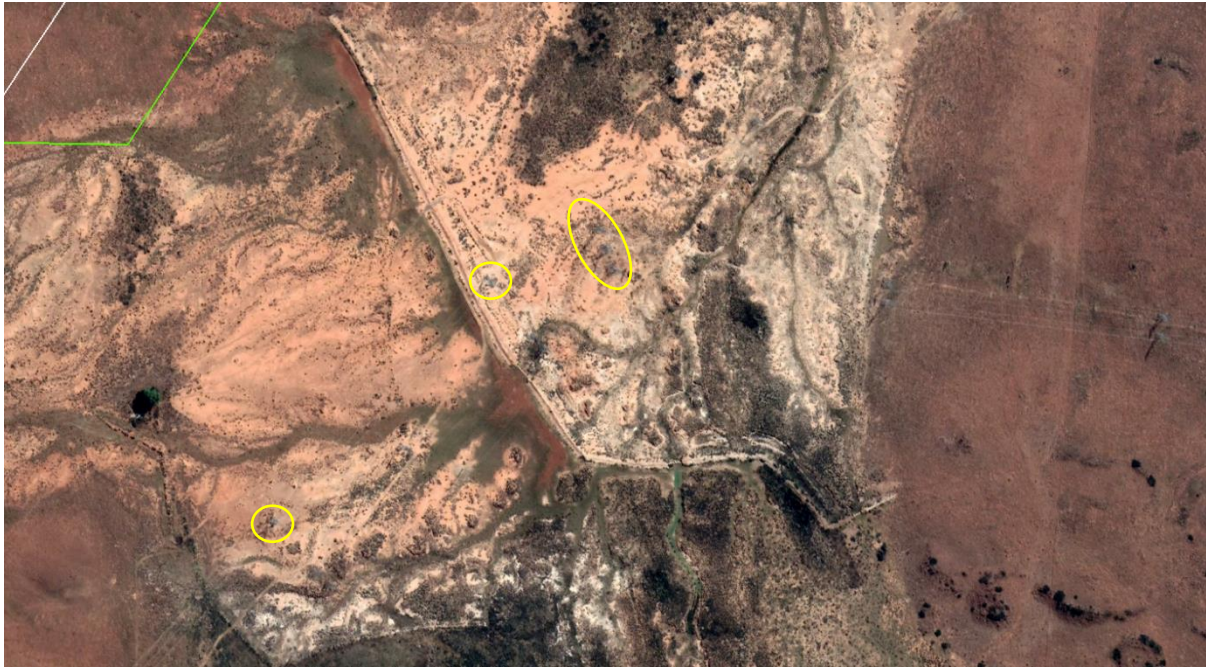
Figure 5-6 Illustration of existing instream weirs structures and powerline pylons (yellow circles) within the drainage features (Google Earth)

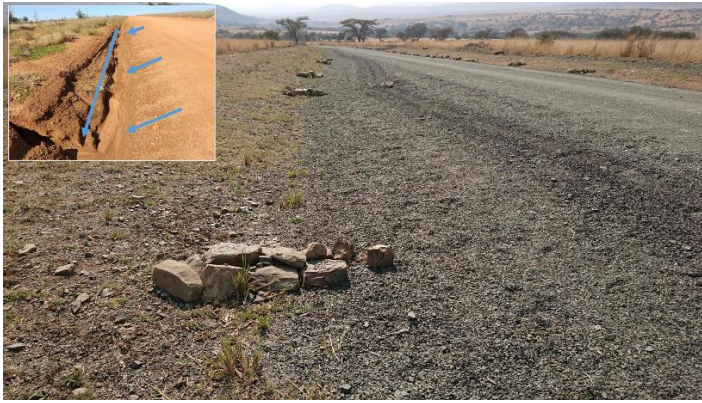
Figure 6-3 Example of road margin erosion prevention

- Energy dissipation, such as stone berms or blocks must be strategically placed along the road margins for the entire road network as surface runoff leaves the roads and enters the surrounding environment with the potential for severe erosion. The steeper the slope of the road, the more regular the berms should be spaced and can be as close as one meter apart where necessary;

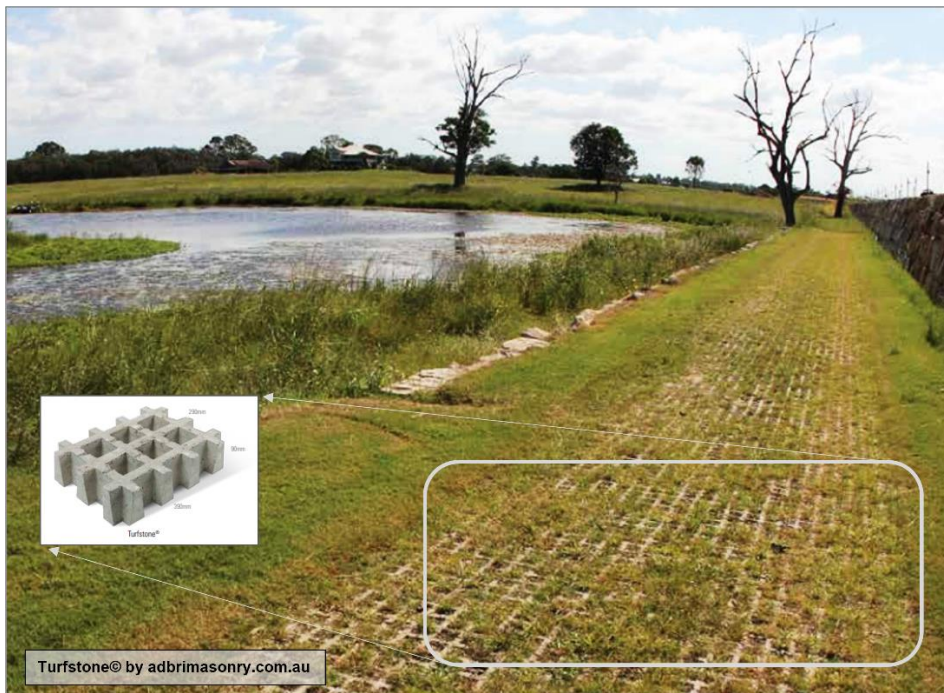
Figure 6-4 Example of permeable paving for roads and habitat maintenance
